Oystermouth Castle Repair Work
September 1997

Report prepared by S H Sell
on behalf of the City and County of Swansea

Project No. A404
Report No. 97/075

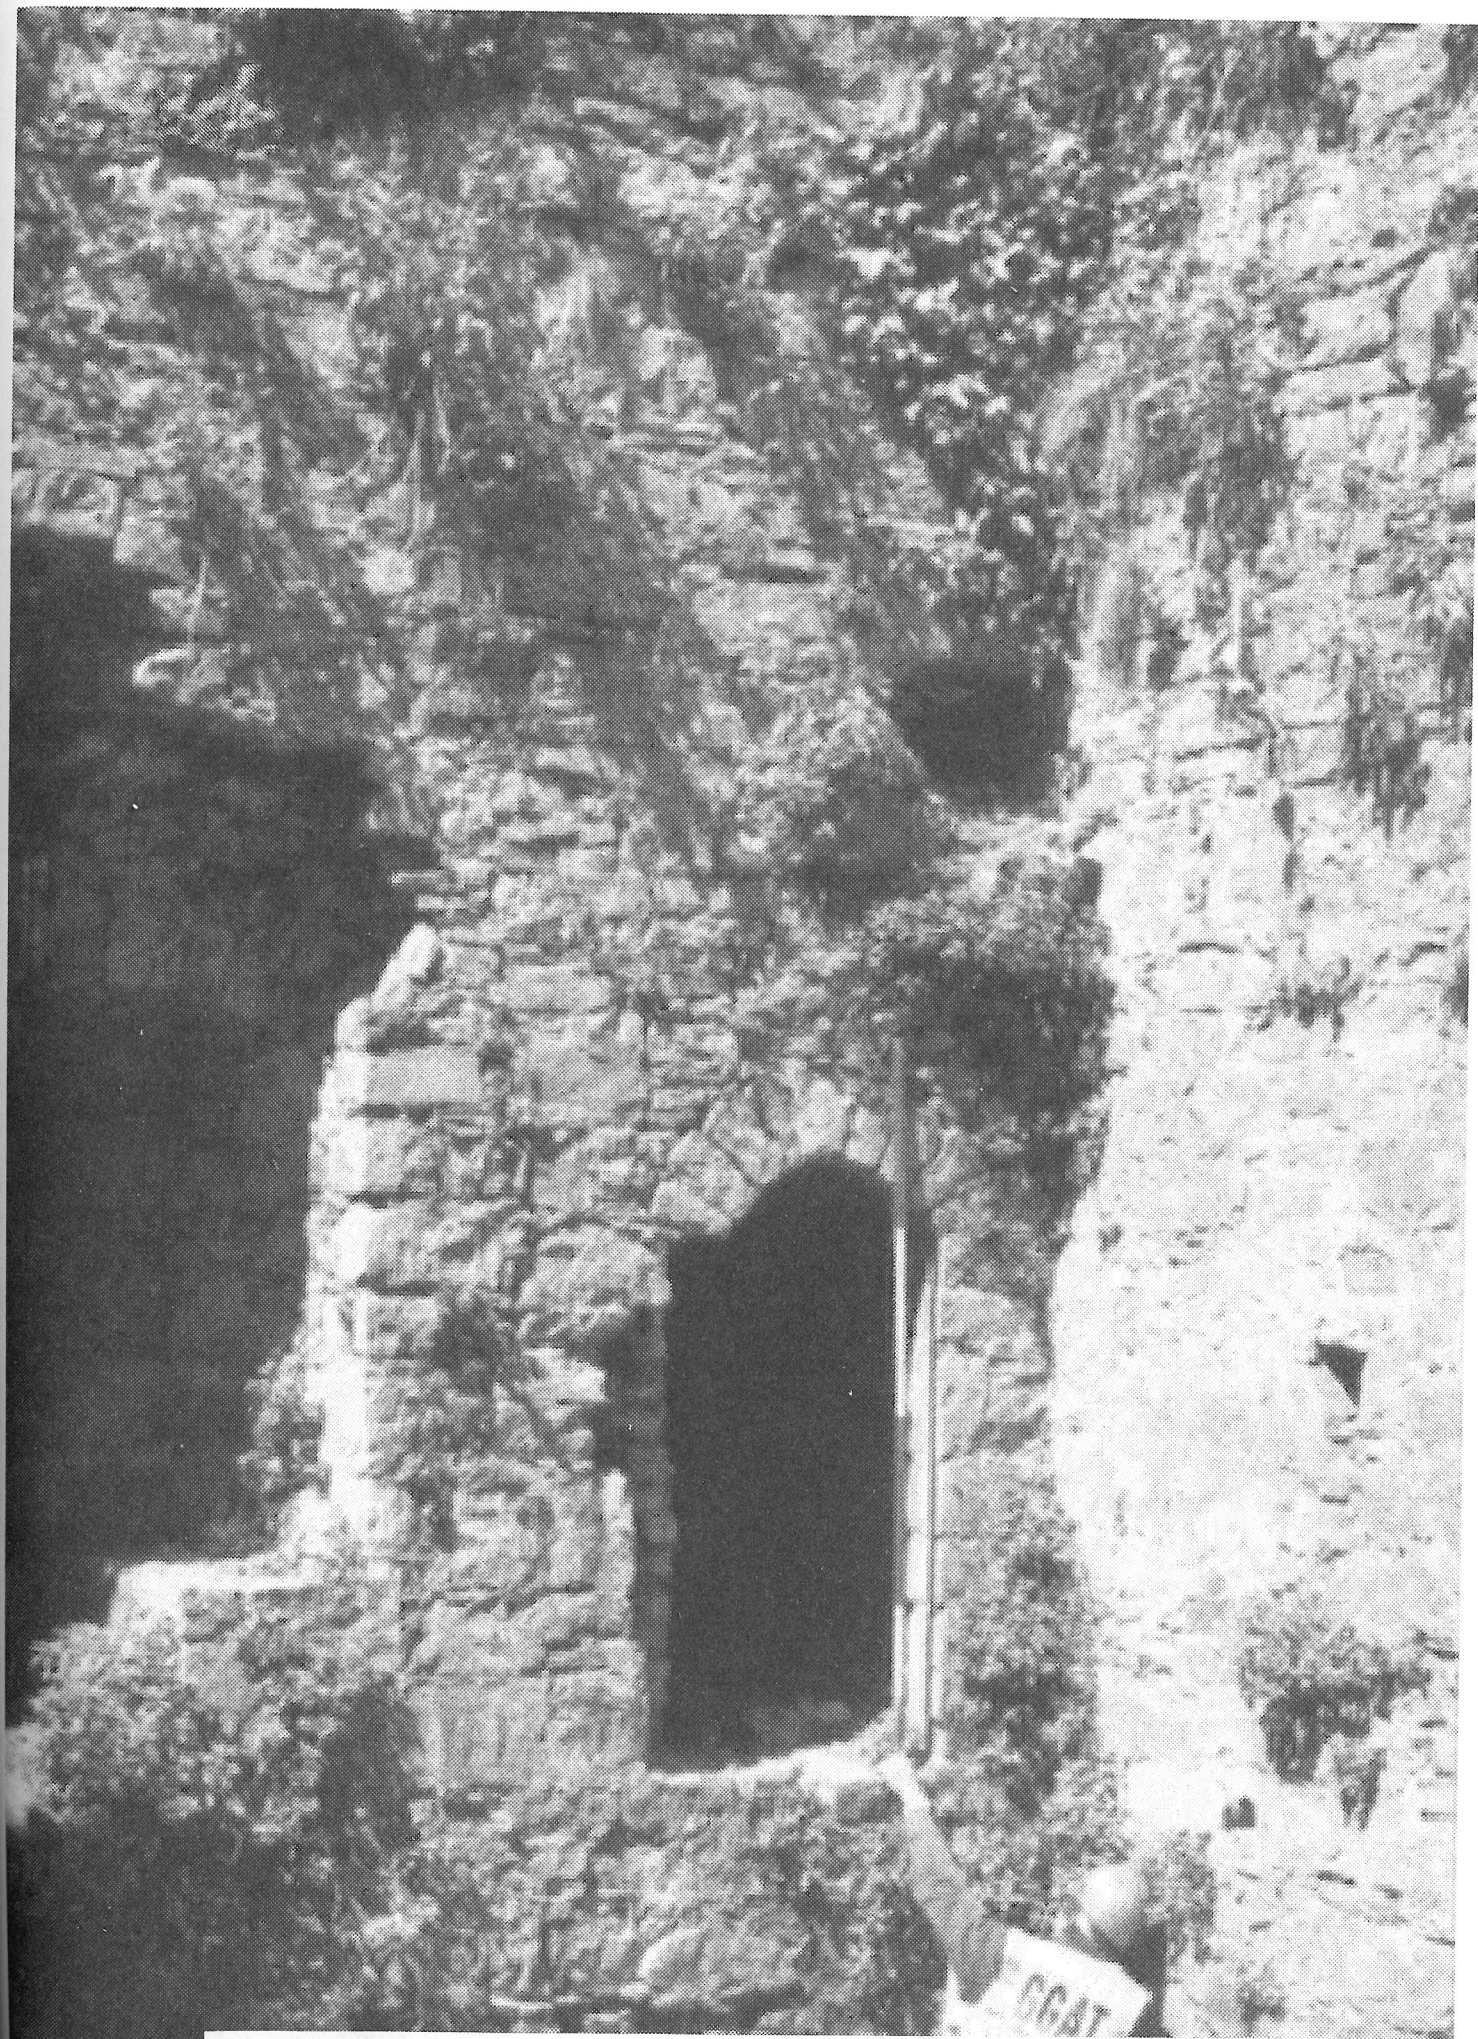
H. (West wall of the West Block, South Range). The entire wall, which was in poor condition generally, was cleaned, grouted and repointed to its full height, but excluding the uppermost surfaces, using an approved mortar mix. Repairs were effected to all openings where unsound masonry occurred, using local stone as necessary. As a matter of structural safety and following consultation with Cadw the arch over one of the blocked windows was rebuilt with new lias limestone blocks. This was the only instance of facework being undertaken using dressed stone, and the appearance is at once sympathetic and distinctive.

Area H North corner of west wall before repair work

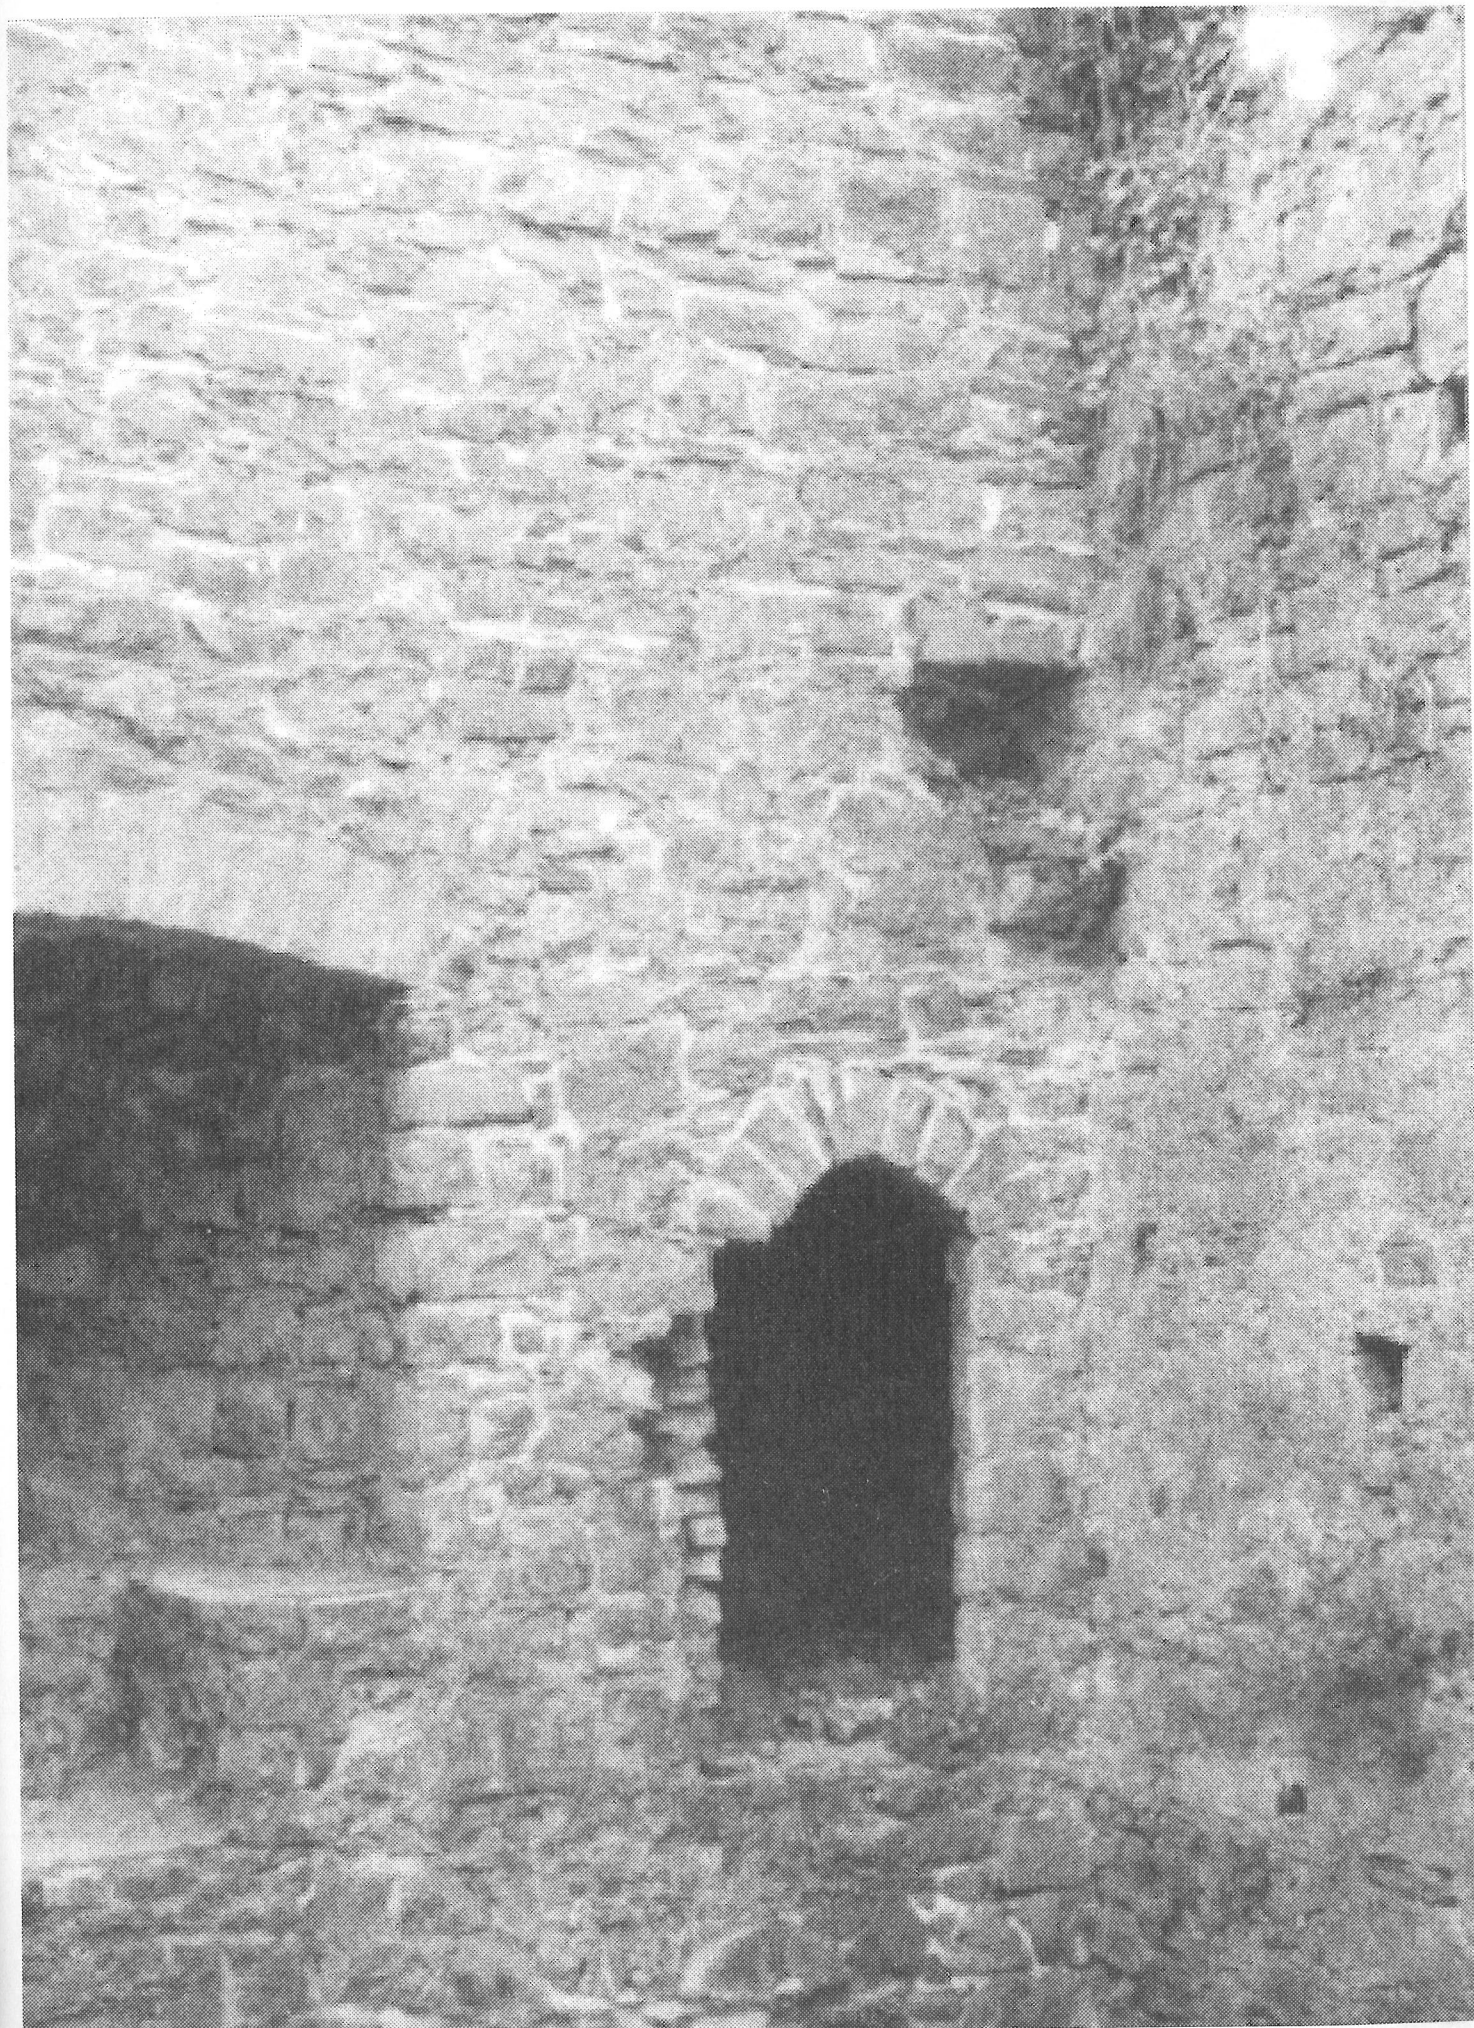
Area H North corner of west wall after repair work

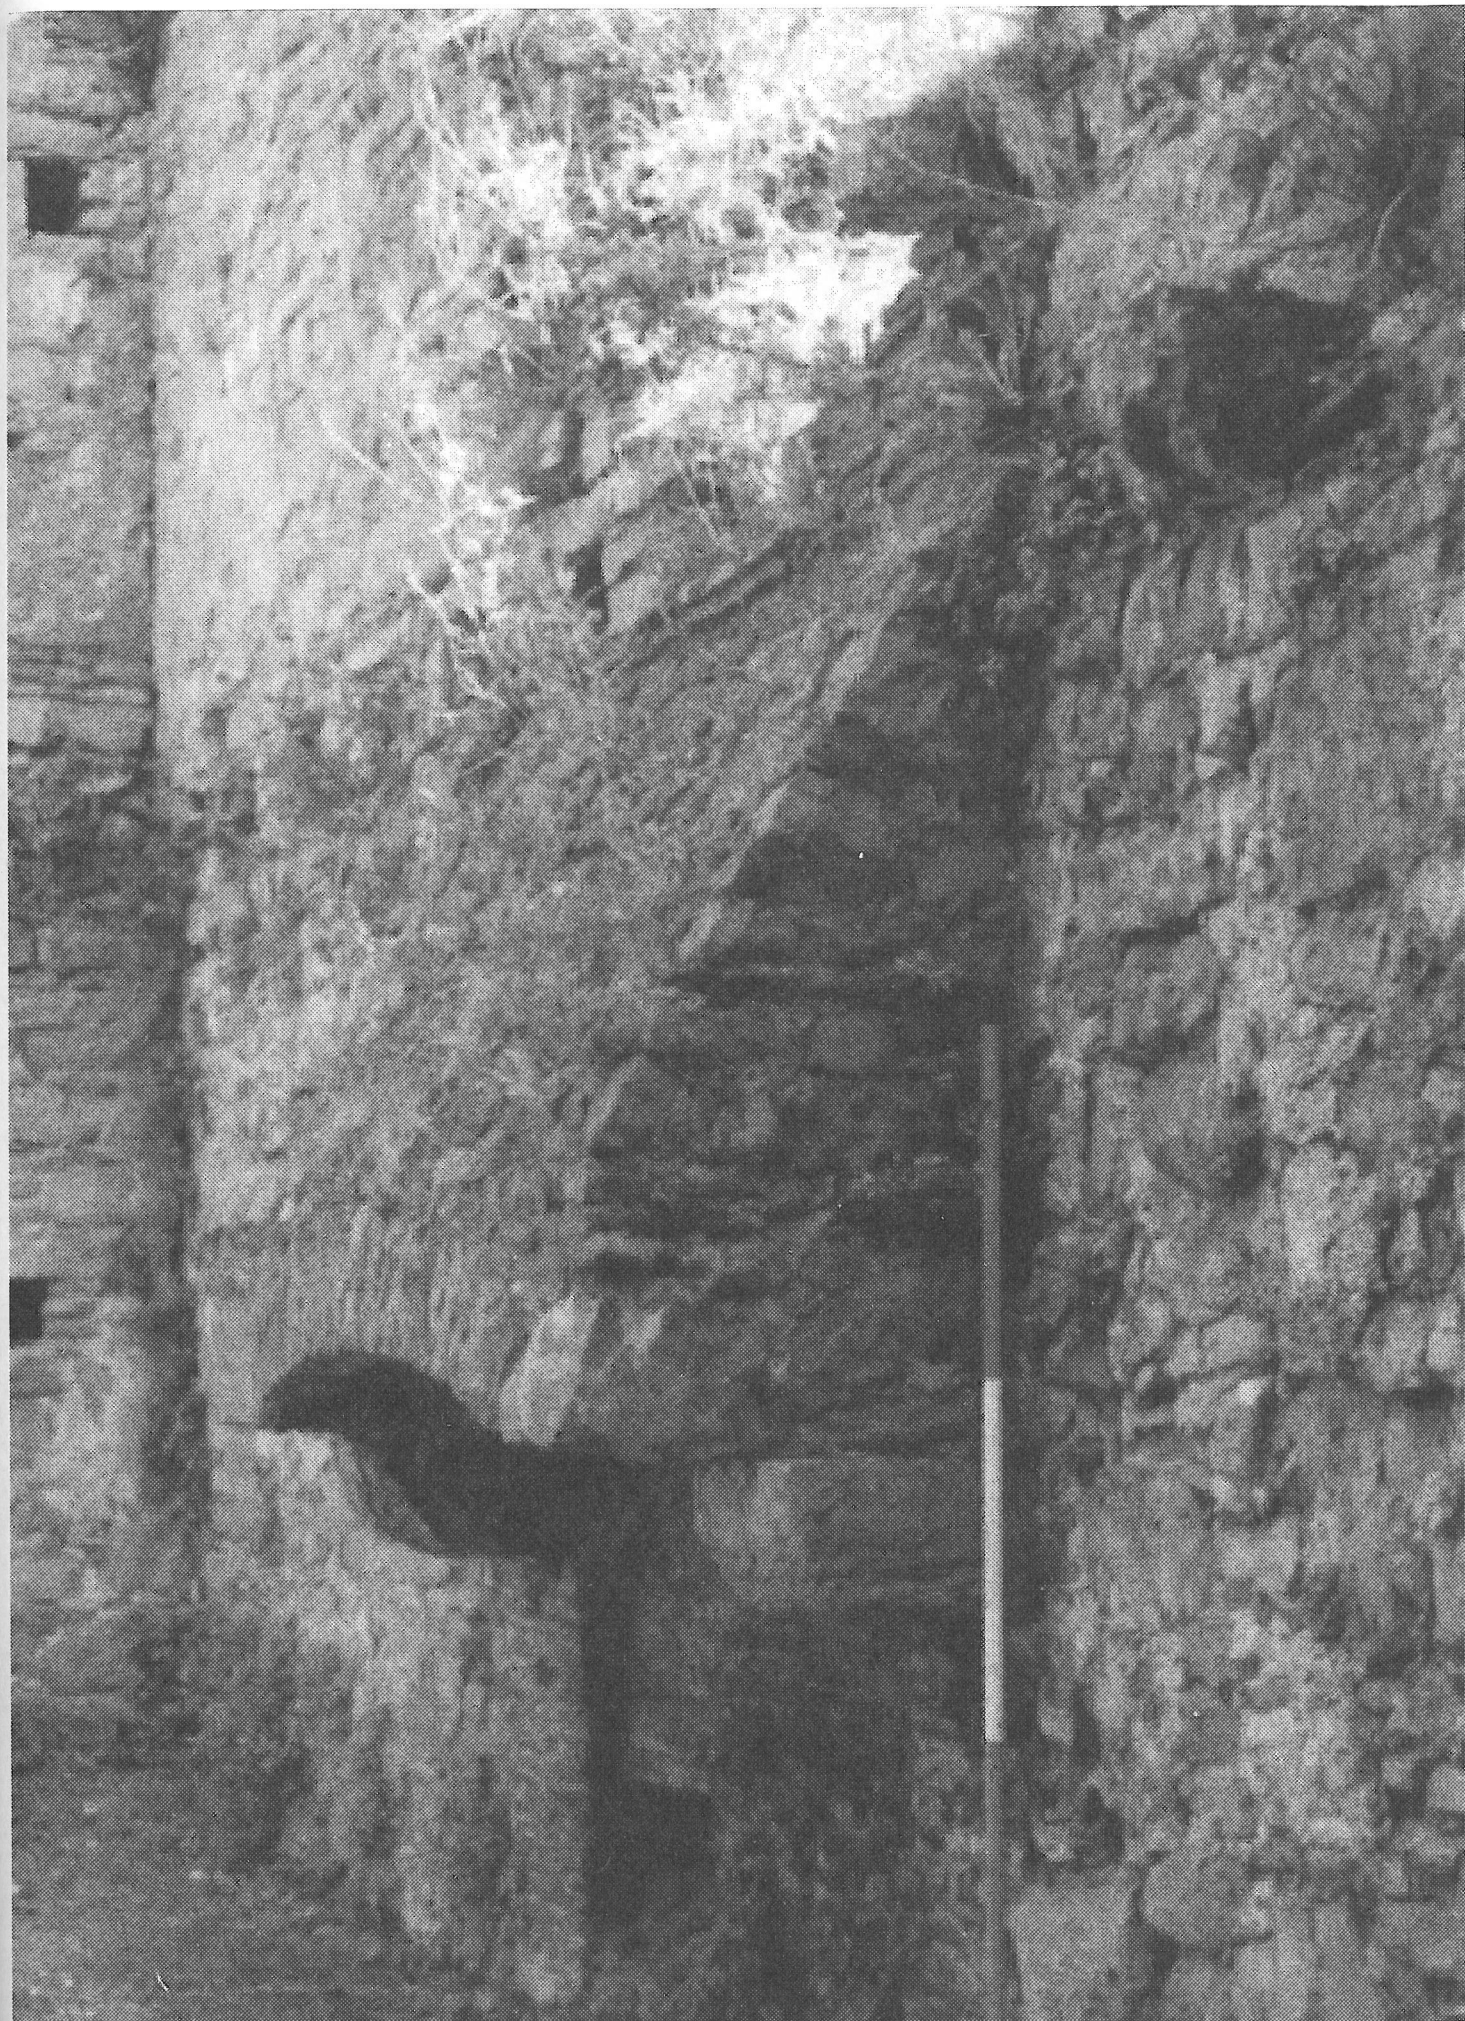
J. (Back to back fireplaces in the wall between the Keep and the later extension to the north (Central Block)). The fireplace on the north side is in good condition with its hood intact and only required cleaning and repointing; that to the south was much less complete and was consolidated using local stone where necessary. A horizontal strengthening bar to support the remains of the hood has not been provided, however, and the poor condition of the wall immediately to the east has already been noted (see above, 2.1.7).

Area J North fireplace before repair work

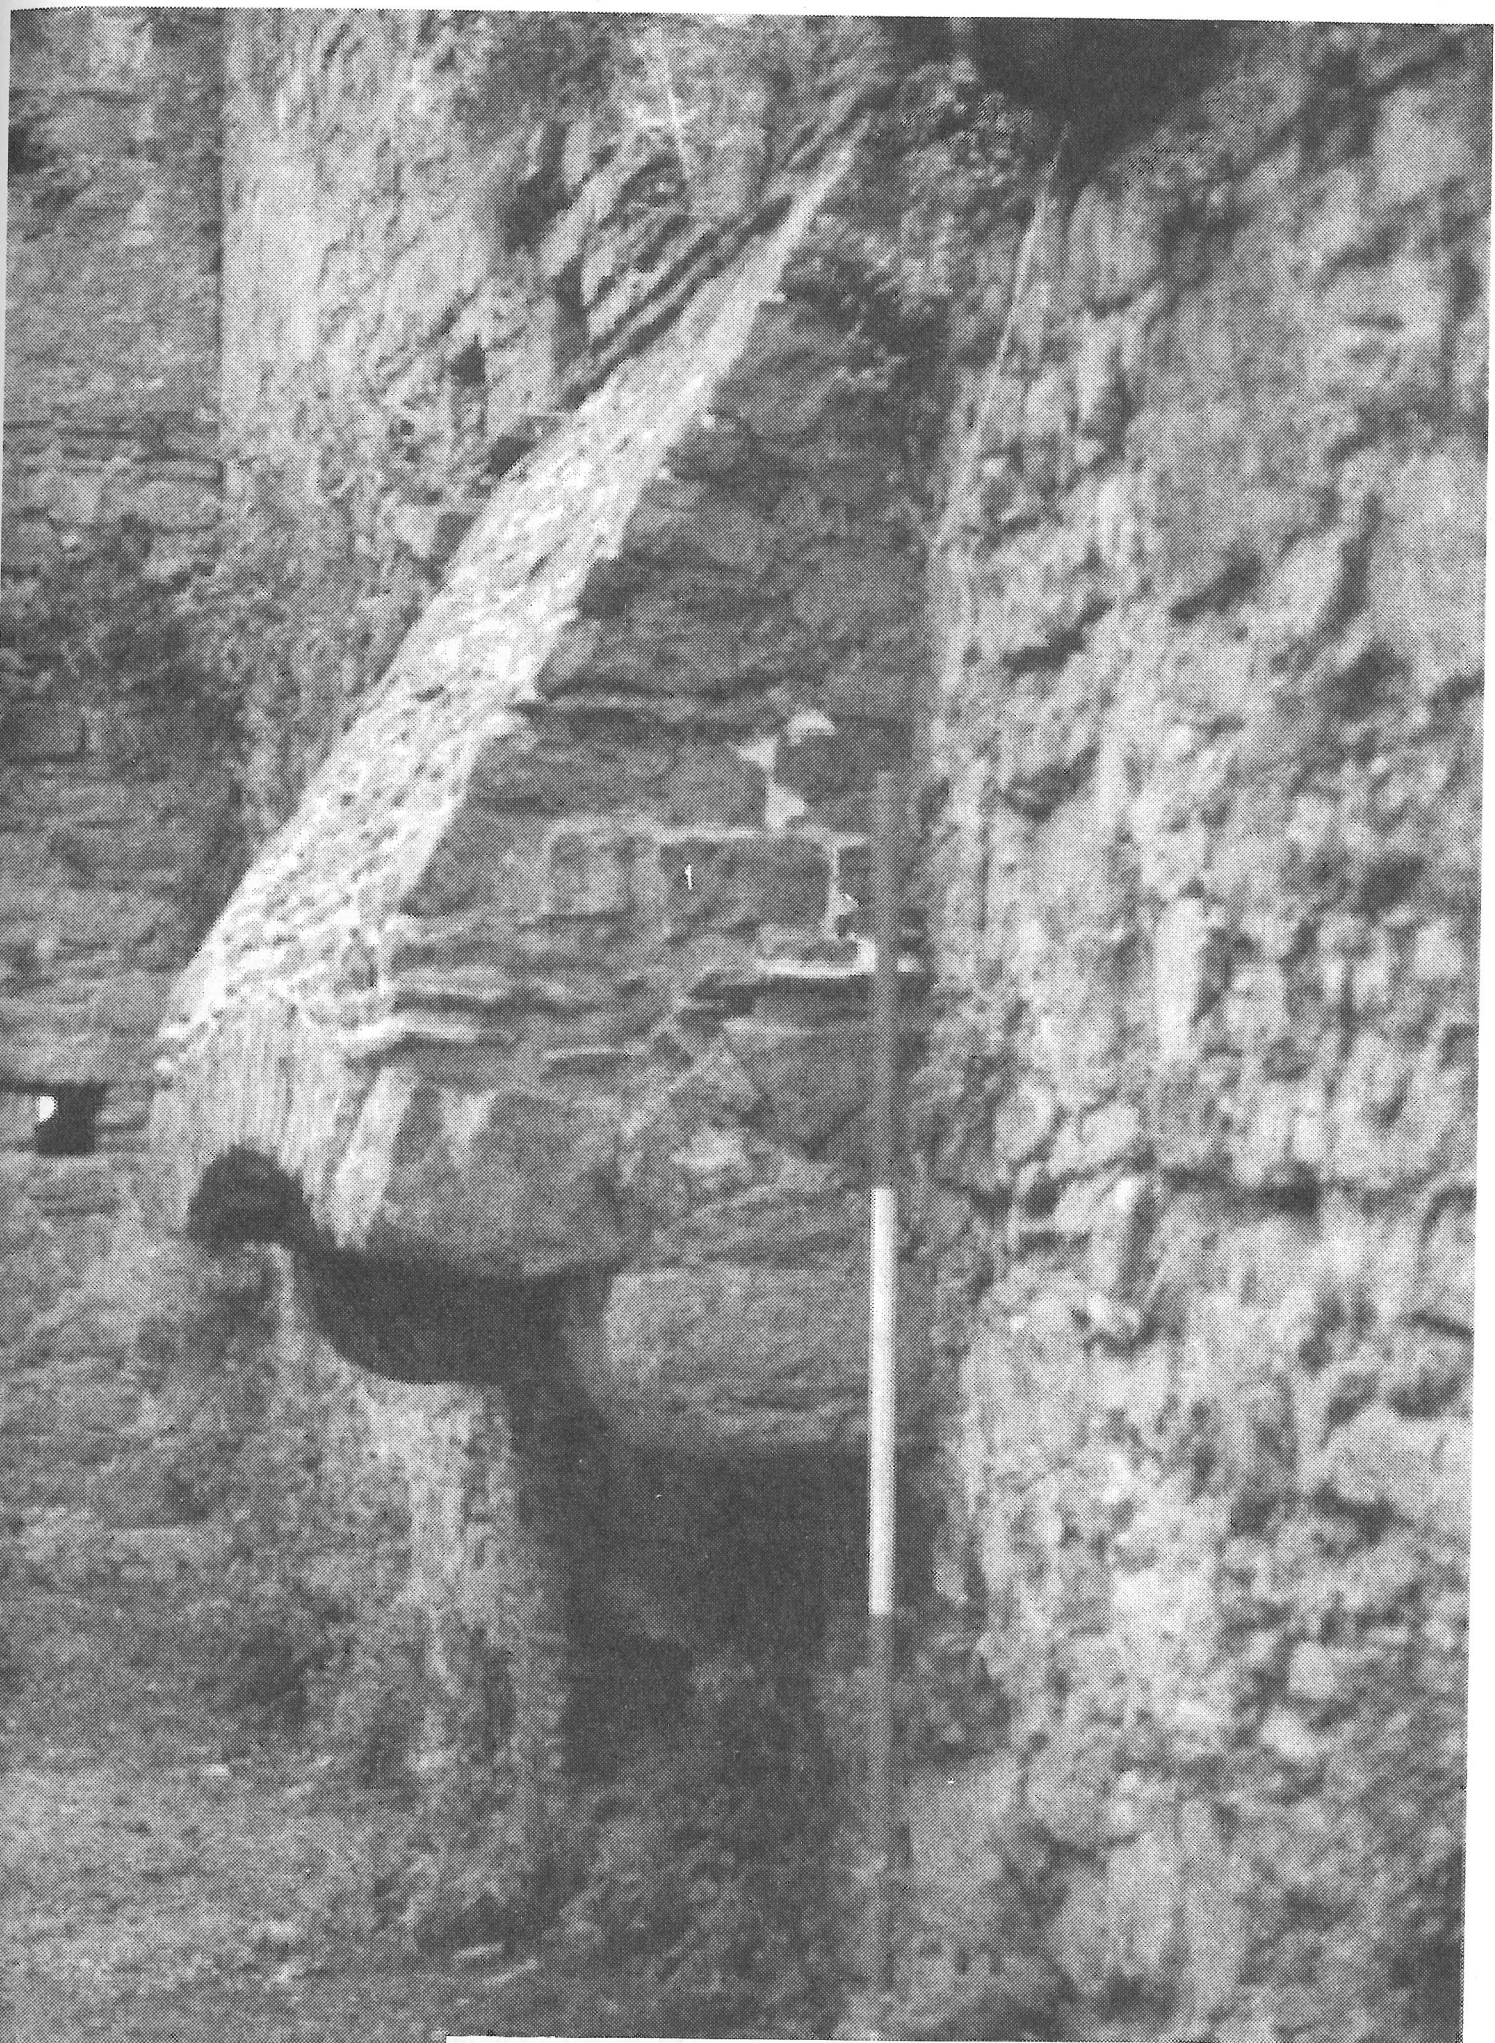
Area J North fireplace after repair work

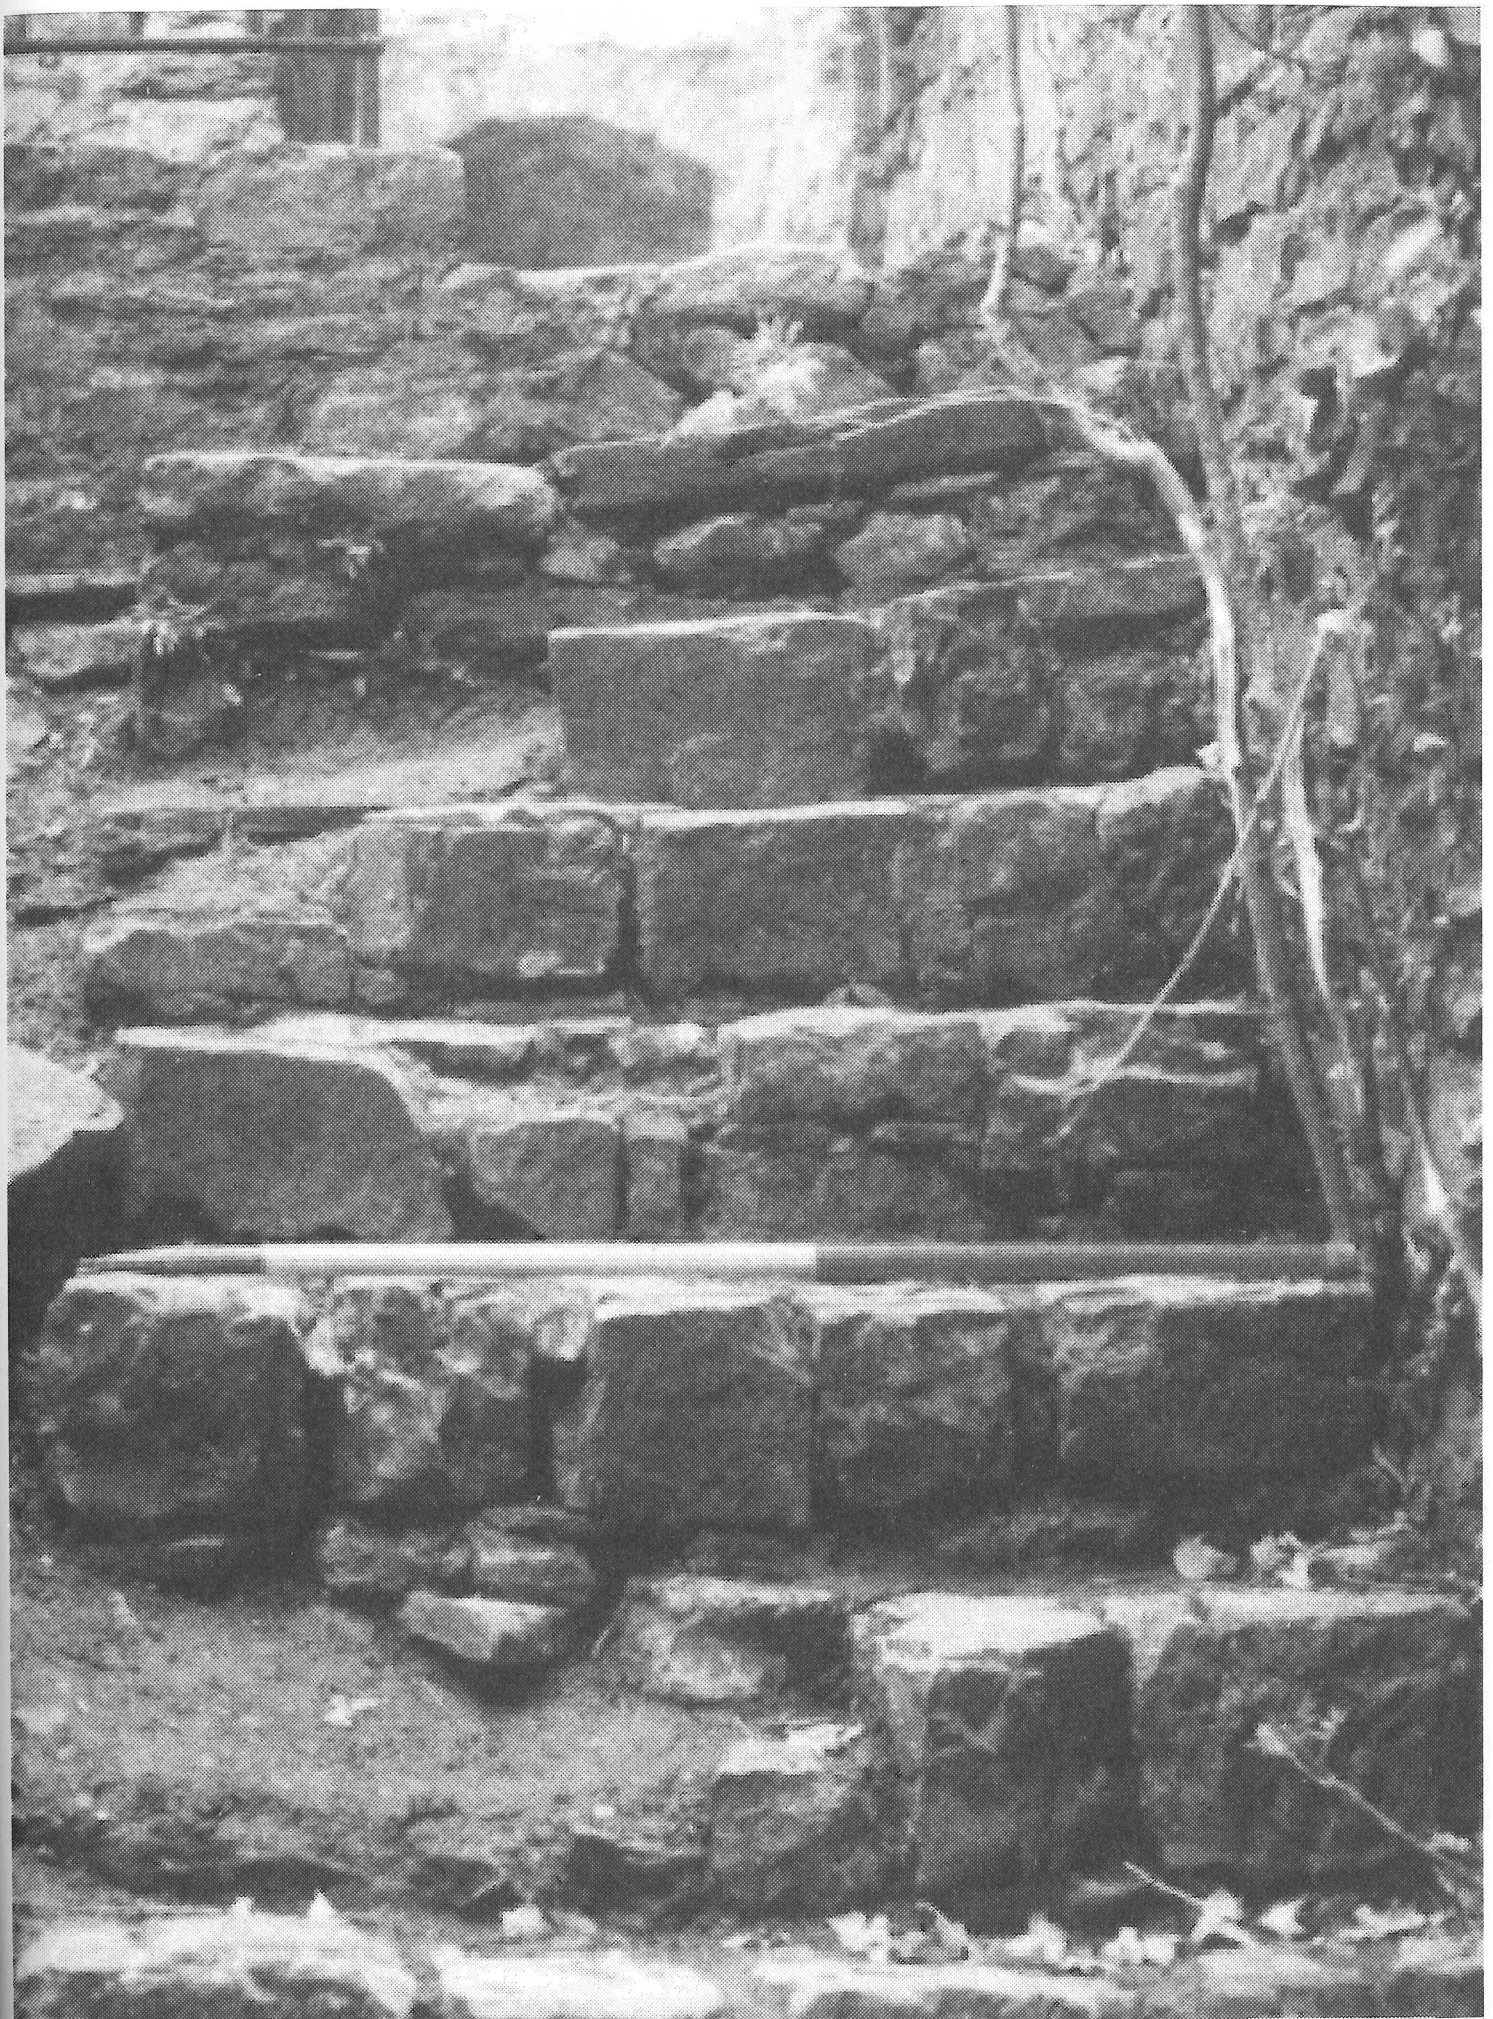
L. (Steps descending to the undercroft of the northern part of the Central Block). These steps were unsafe, overgrown and to some extent buried. Repairs were carried out as G, above, with clearance of overburden to expose the complete flight being undertaken under archaeological conditions. The handrail on the original specification has not been provided, however, despite the facility for placing it on the made ground to the eastern side of the flight

Area L Steps before repair work

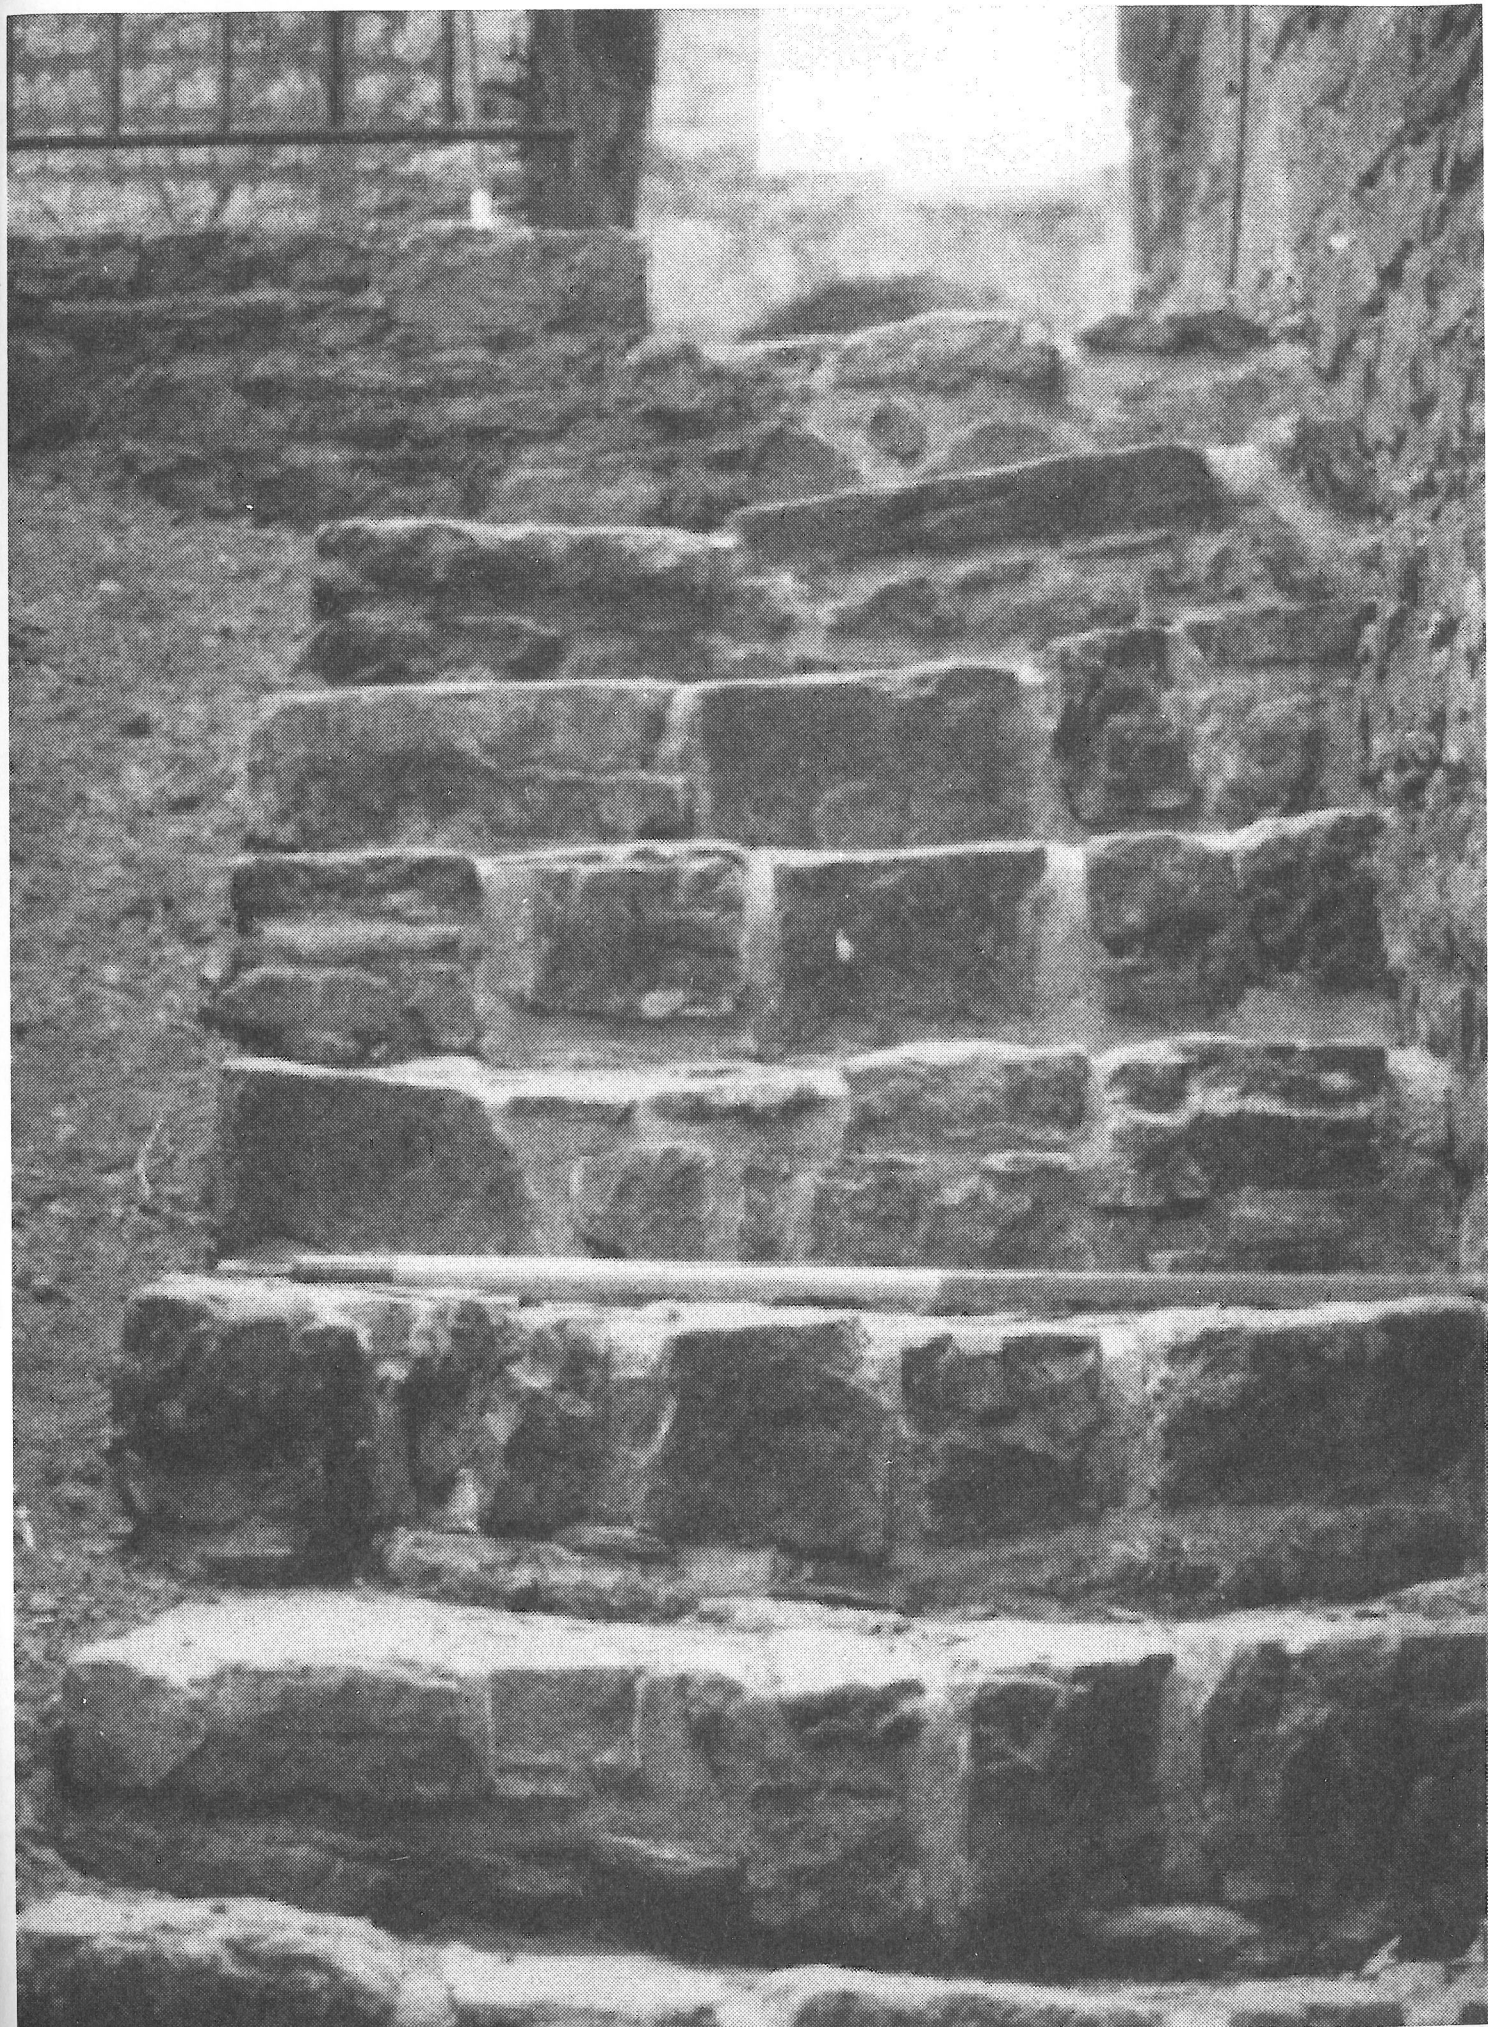
Area L Steps after repair work
